CALIFORNIA DIVISION OF MINES AND GEOLOGY

Fault Evaluation Report FER-12

March 14, 1977

1. Name of fault: Santa Ynez fault (south branch).
2. Location of fault: Gaviota, Sacate, and Solvang quads, Santa Barbara County (see index map, figure 1).

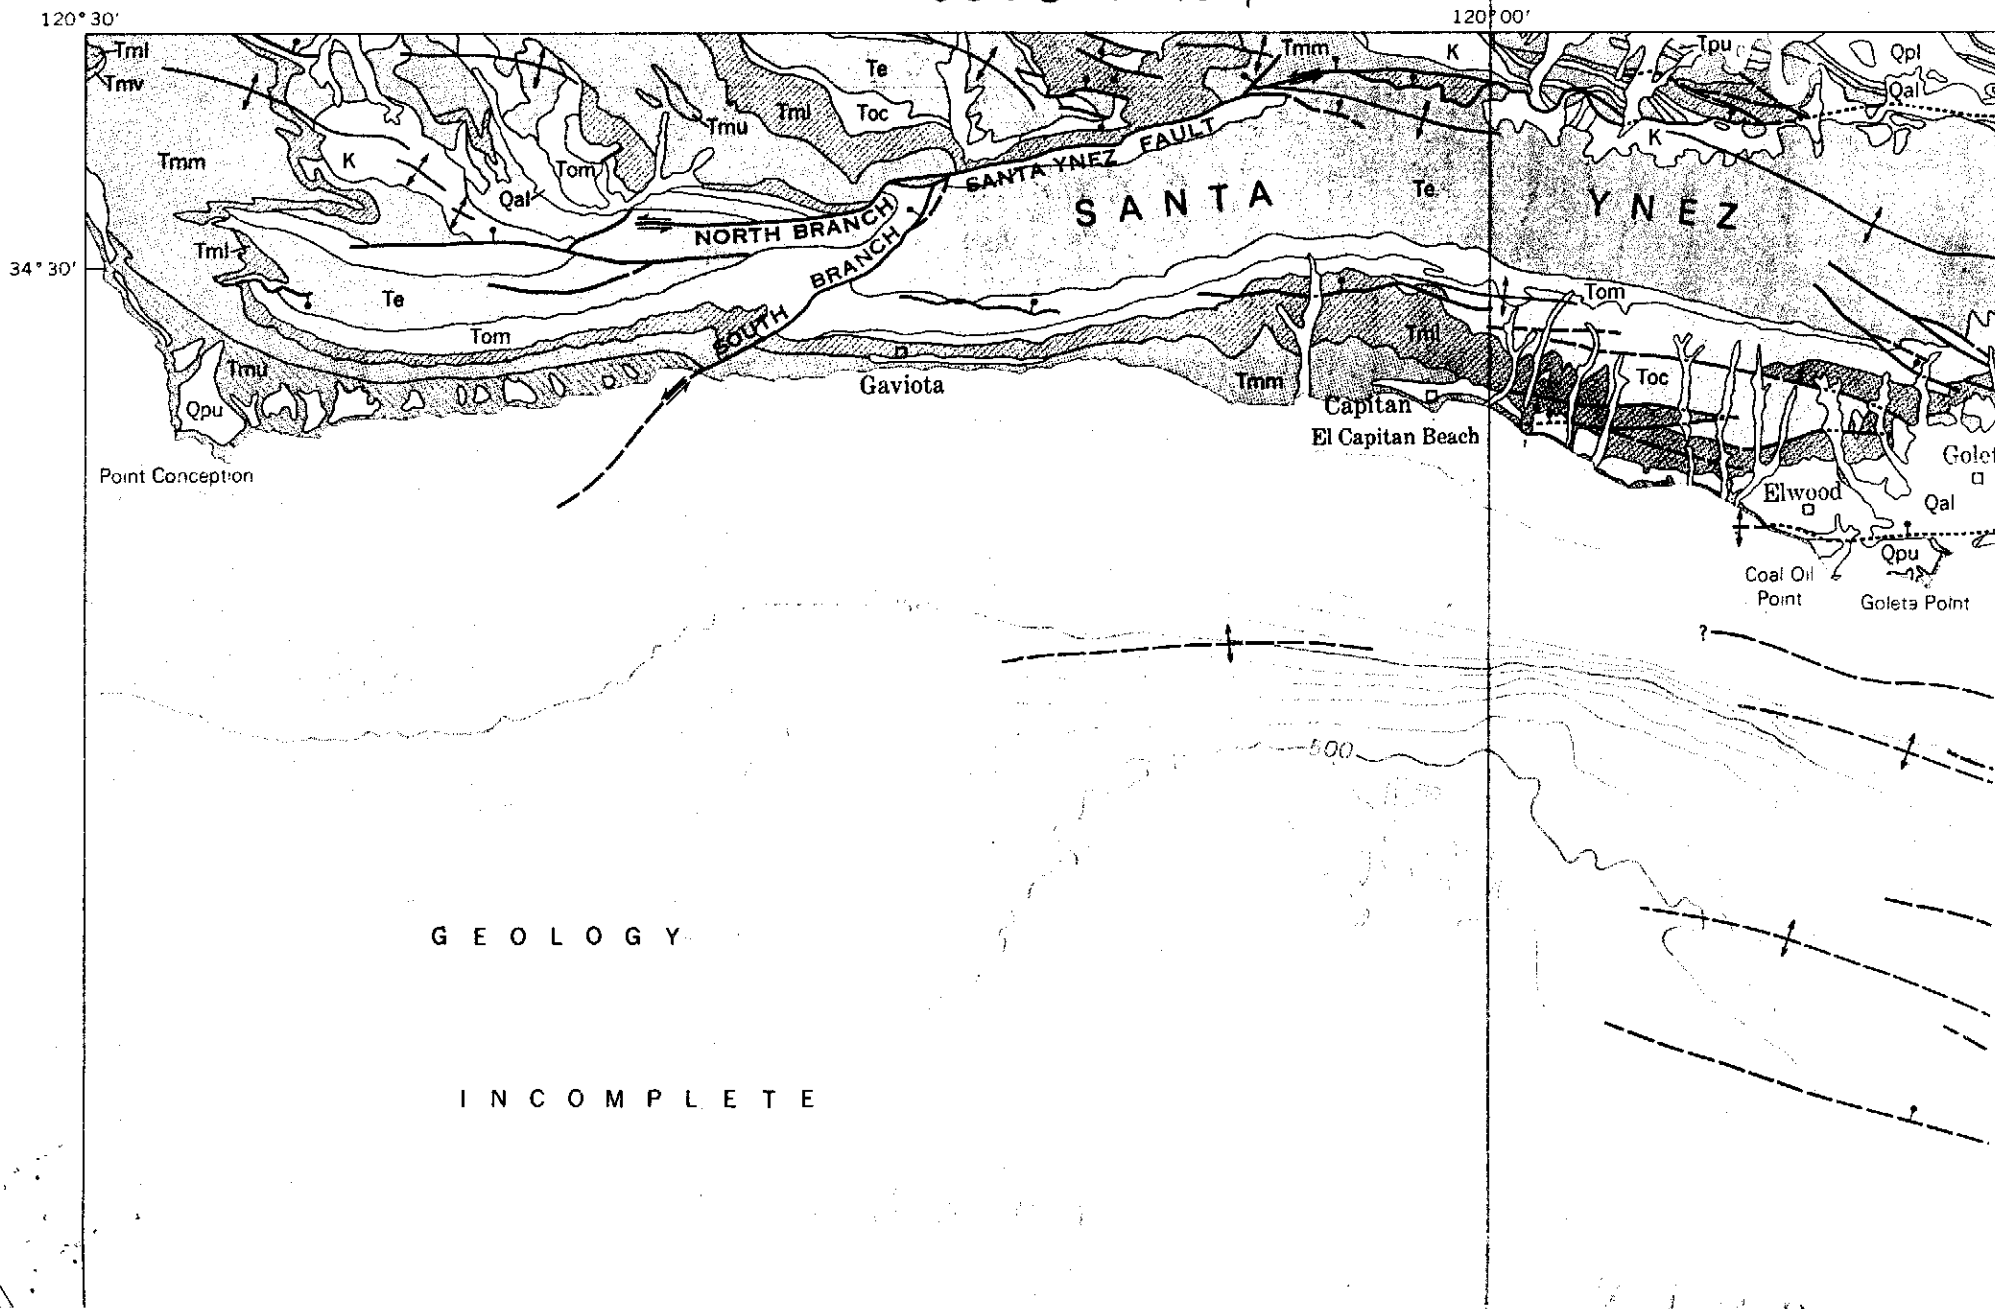
Fig. 1

*Veeder (1974) shows the
fault offshore. Dibblee maps
it's onshore extent*

fault to bifurcate at the northeast end and to branch in at least two *other* places (see figure 1). Geologic evidence of faulting is apparent along the fault where the contact between upper and lower Monterey Formation *apparently* is offset left-laterally, and where rocks of the Rincon and lower Monterey Formations are in contact. The fault dips between 60 and 85 degrees to the NW. Dibblee shows the SE side of the fault to be up relative to the NW. Weaver and Dibblee (1965^{P. -}) show conflicting evidence as to the nature of the principal movement along this fault.

indications of a scarp in the bedrock offshore put this fault in the very latest Pleistocene and possibly Holocene category (see figure 1). Moore and Taber classify this fault as active apparently on the basis of reported historic elevation changes (see Willott below).

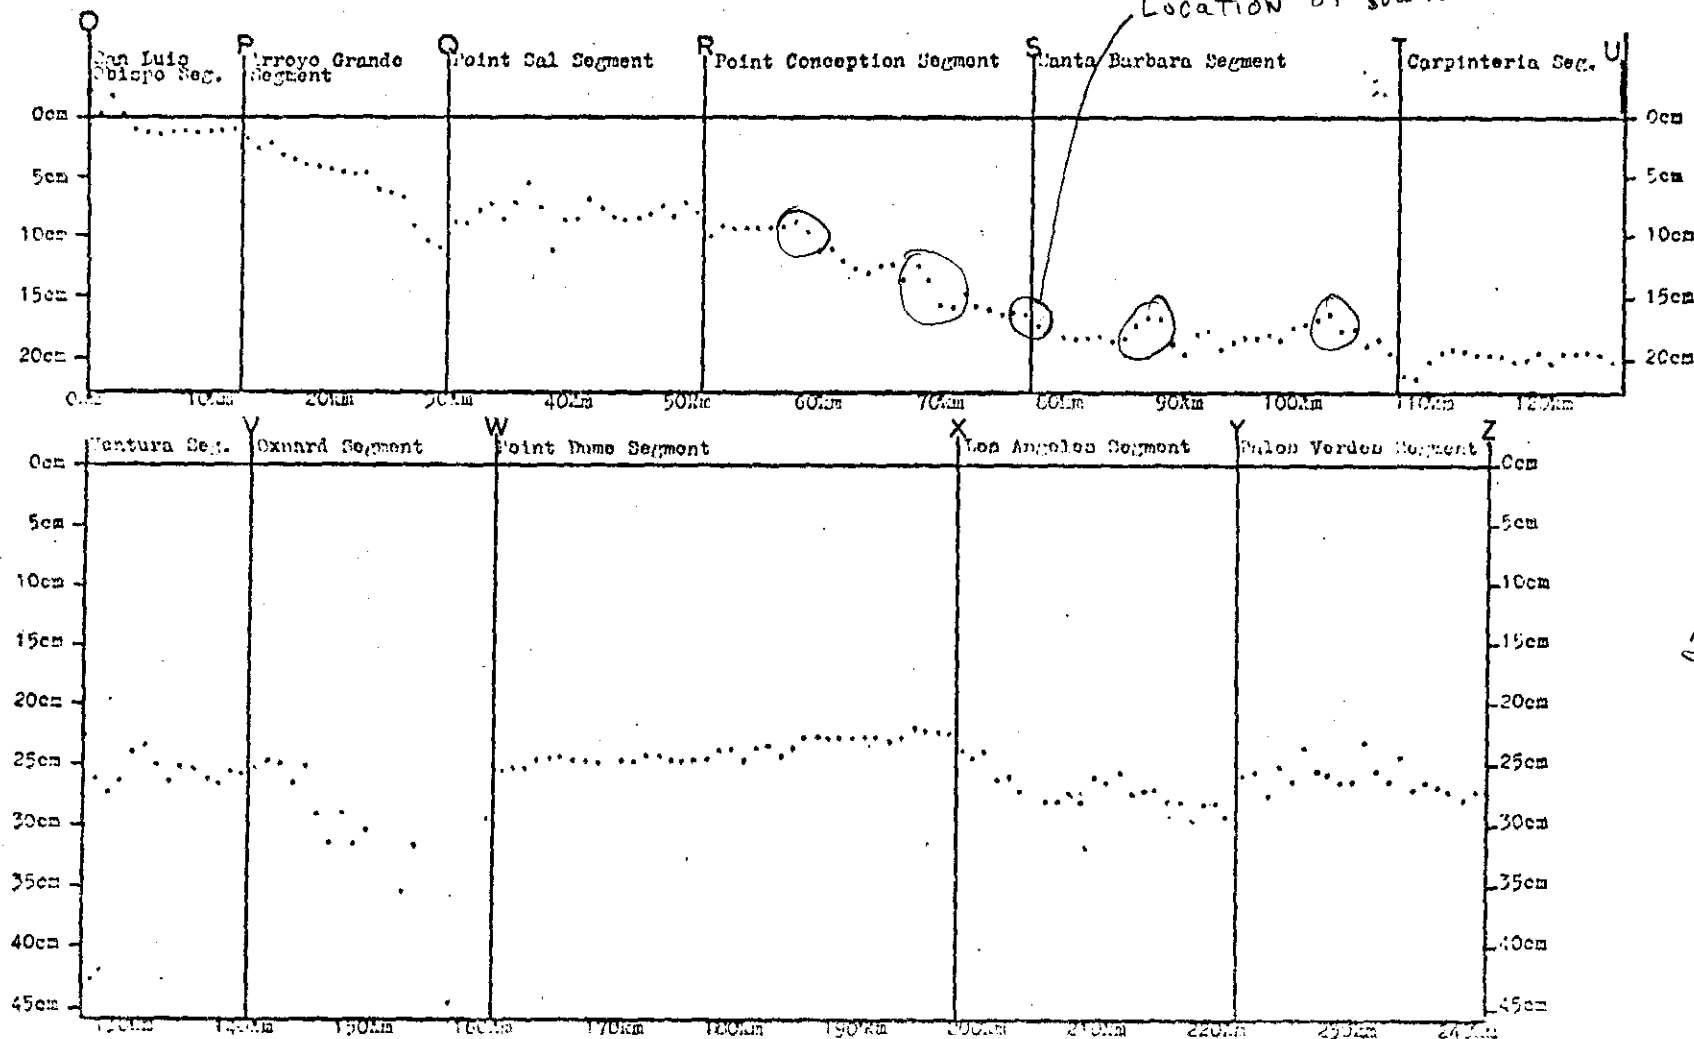
Fig. 2

Willott (1972, p. 30), using data from a precise level line survey, states that the south branch of the Santa Ynez fault is the cause of a 1.5 cm elevation change ^(east side down) over the last 11 ~~000~~ years. This change, he says, takes place between two precisely surveyed benchmarks located on the Southern Pacific rail lines (see plate 1). However, other elevation changes 3 or 4 times ^{as} great occur within 10 km either side of this location (see figure 2). No known faults exist at these other locations and no explanation is given for their existence. Willott's data does seem to show that the entire area eastward from Pt. Conception is tilting or subsiding to the east. Choosing one small elevation change out of multitudes of other anomalies and attaching it to the Santa Ynez fault does not appear to be appropriate.

Fig. 10. Graph of the change in elevation between 1957 and 1971. 1957 elevations set at zero. Dots signify bench marks.

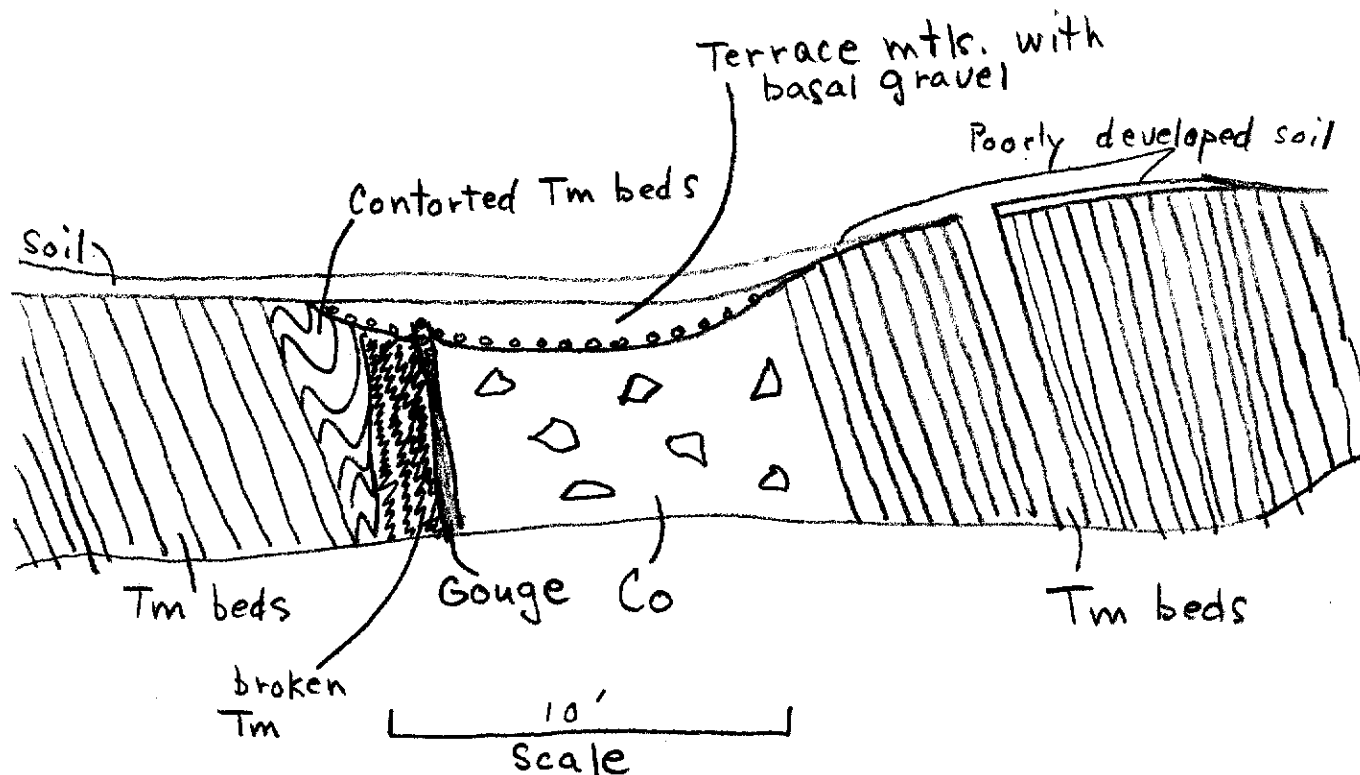
Fig. 5

3) This locality is located up slope from number 2 where a fault crosses a NW-SE trending spur (see figure 5). Here a cut made for an old road provides a fairly well exposed section. The beds of the Monterey Formation again are contorted and sheared. Again, a gap (narrower than at 2) exists in the Tm beds. Colluvium has filled this gap. At the south margin of the gap a 2" wide fault gouge zone forms the boundary between the colluvium and the sheared and contorted Tm. The fault possibly extends upward into a gravelly terrace material. Some of the gravel at the base of the terrace is mixed in with the gouge. So it would seem that faulting occurred during or after deposition of the terrace deposit. The most important evidence found at this outcrop is that ^aone-foot thick, poorly developed soil overlying these units appears to be unfaulted. In fact, the fault could not be traced completely through the terrace materials.

View looking west
above Alegria Canyon
on the west side.

Gouge = fault $N70^{\circ}E$, vertical to steep northerly dip

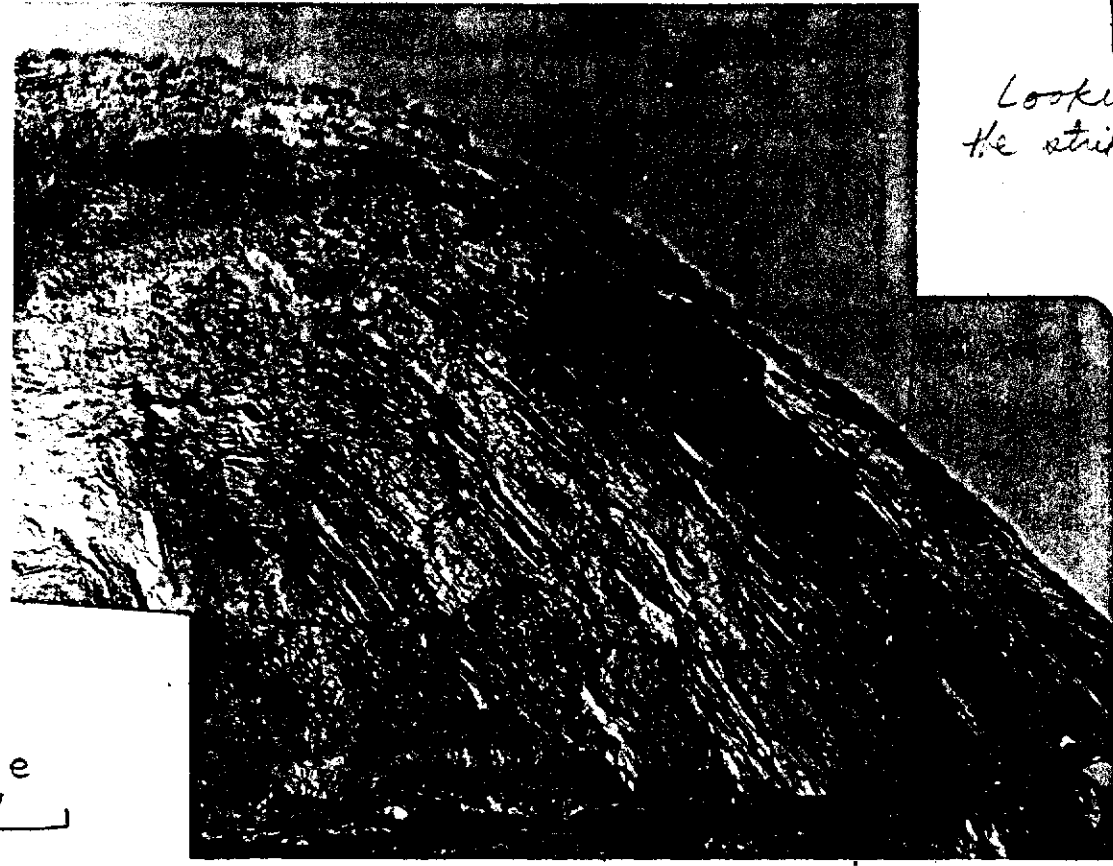
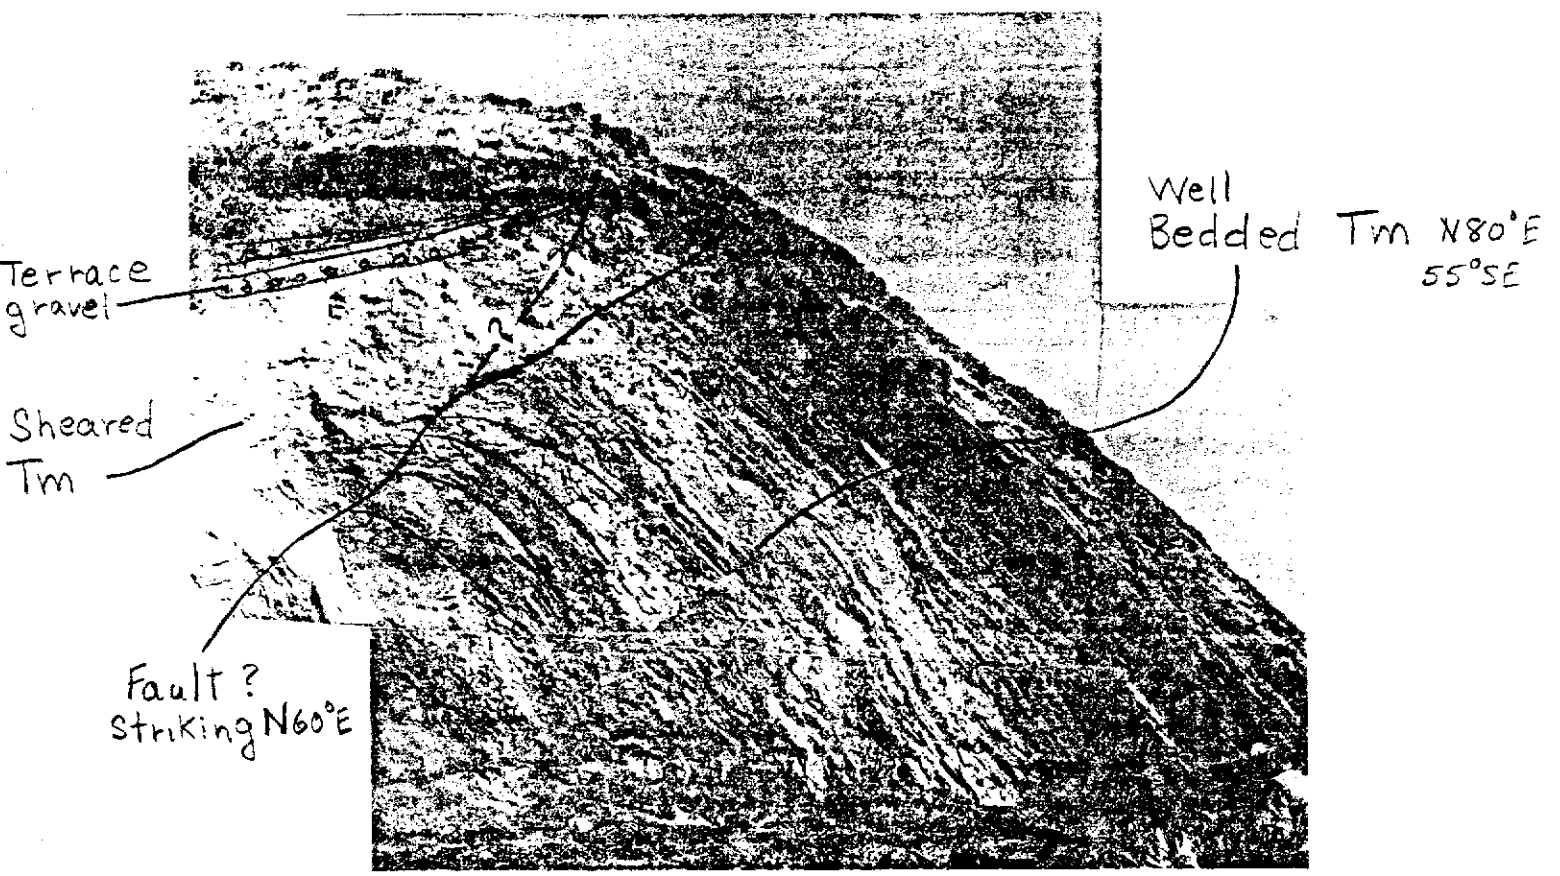
Fig. 6

- 9) Beds of the Monterey Formation, striking $N 80^{\circ} E$ and dipping $55^{\circ} SE$, are exposed in the seacliff (see figure 6). About 300 feet west of this outcrop are beds of the Siquoc or Monterey Formation which generally strike $N 25^{\circ} W$ and dip $30^{\circ} SW$. Within this 300-foot zone are poorly exposed, highly contorted, and sheared Monterey beds. At the eastern margin of this disturbed zone, the Monterey Formation is overlain by

Looking NE along
the strike of the fault

Tm — Monterey Formation ^{between}
? Fault or boundary of sheared & well bedded rock

terrace gravels which appear to be slightly upturned and may be faulted against the Monterey Formation. The terrace deposit is not exposed on the east side of this shear zone. It could not be determined, due to the steepness of the seacliff, whether the terrace deposit is actually faulted. The significance of this locality seems to be that the fault is not very well defined. There could be any number of faults within the 300' disturbed zone described above. West of this zone the rocks are not sheared; also the rocks east of zone are not sheared.
